Innovative Rehabilitation of a Parking Structure

by Bijan O. Aalami and David T. Swanson

Describes the principal considerations in the evaluation, design, and construction that led to the successful rehabilitation of the multi-level Pier 39 concrete frame parking garage in San Francisco. Gradual deterioration of insufficiently protected heat-seal wrapped post tensioning had rendered the garage unfunctional and necessitated extensive shoring. Rehabilitation options, economic evaluations, structural computations, post-tensioning hardware, and construction highlights are discussed.

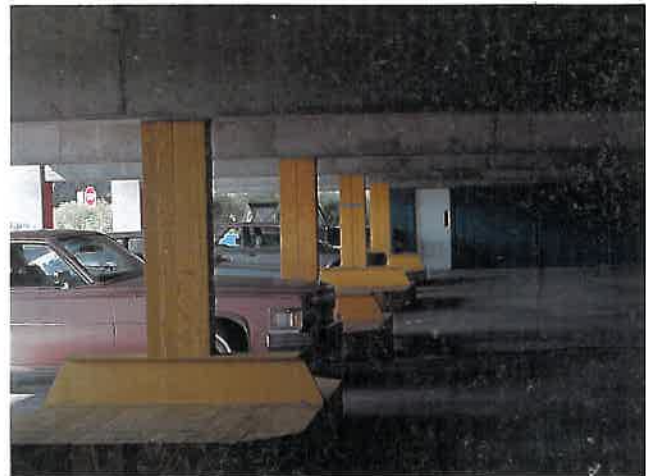
Fig. 2 — (below, right) Prior to rehabilitation, deterioration of the structure had necessitated extensive shoring.

Based on the investigations of the structural consultant, 12 in. square (300 mm square) timber supports were placed at beam quarter points. The load from these supports was distributed to timber mats at ground level. This shoring resulted in a noticeable reduction in the available parking spaces in the garage (Fig. 2).

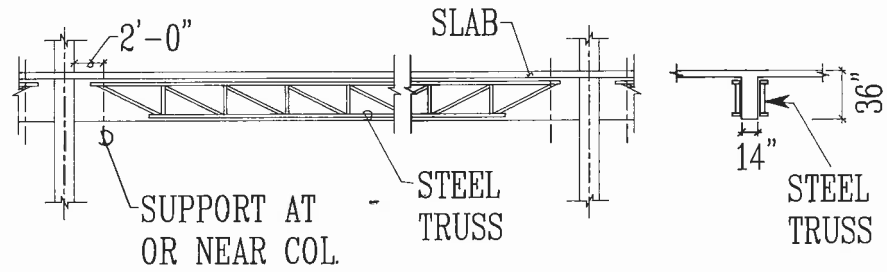
Fig. 3 — (top) Addition of steel trusses was one of the rehabilitation options.

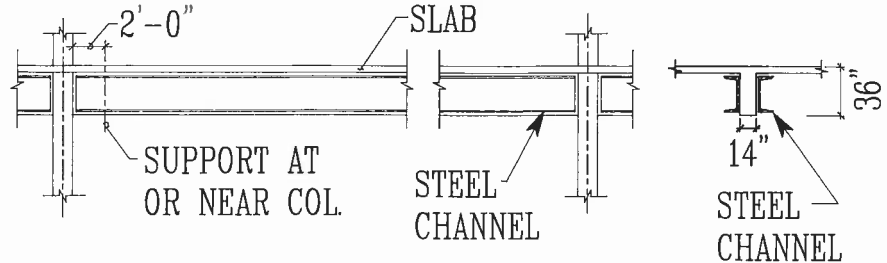
Fig. 4 — (center) Steel channels or I-sections were also considered as alternatives.

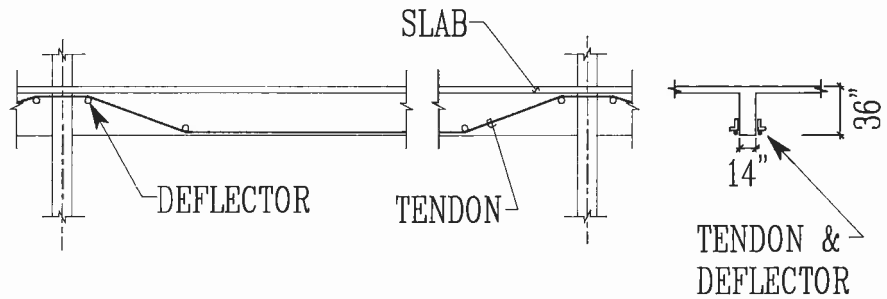
Fig. 5 — (bottom) Externally applied post-tensioning proved to be the most economical alternative. Initial schemes were based on tendon deflectors at third points.

The concrete alternative consisted of adding post-tensioned tendons on each side of the beams as illustrated schematically in Fig. 5.

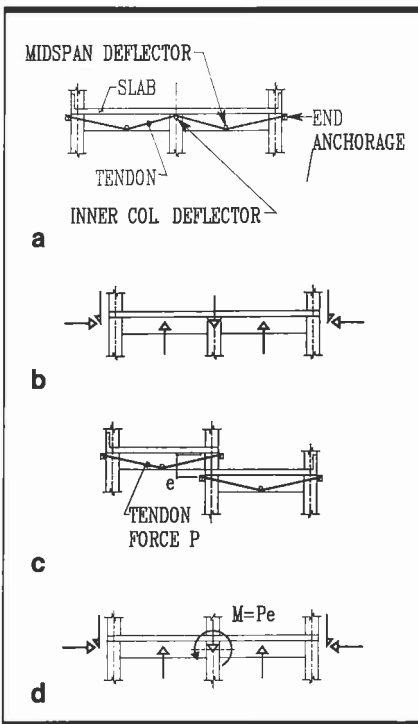
Fig. 6—For the analysis of the beam frames, the externally applied post-tensioning was substituted by the forces it exerts on the structure: a) elevation; b) balanced loading; c) elevation at split level; d) modelled balanced loading at split level.

Beam frames were modeled using the load-balancing concept of post-tensioning design in which a force diagram is constructed from the tendon layout, such as the one shown in Fig. 6. The magnitude of the concentrated forces shown is related to the post-tensioning to be applied. The post-tensioning forces required to satisfy the serviceability and strength criteria described in the preceding were computed using the ADAPT Post-Tensioning software system.*

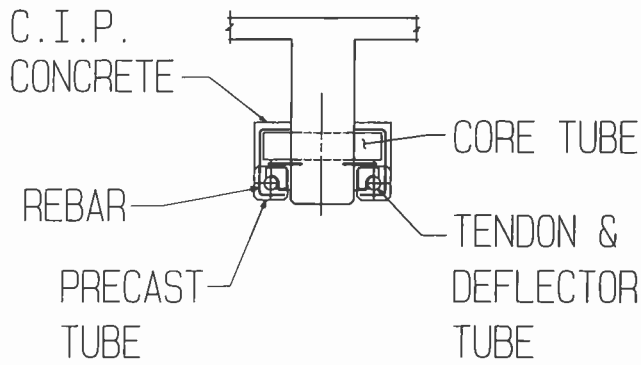
Fig. 7 — (above) The mid-span tendon deflectors consisted of bent tubes anchored in the stem of the beam through a chore tube.

The second component is the deflector, which transfers the vertical post-tensioning forces to the beams and columns. The deflectors were made of 4½ in. (114 mm) extra-heavy pipe. They were connected to the column and beam by slipping through a 4¾ in. (119 mm) cored hole, which was located so it would miss the existing beam post-tensioning (Fig. 7).

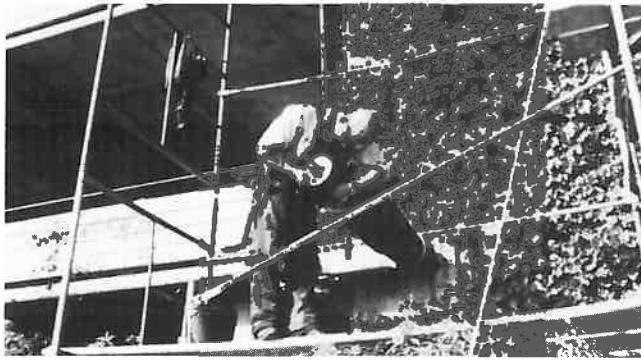
Fig. 9 — Most beams were stressed from outside the building.

The post-tensioning tendons were precut and pulled into their final position during the day shift. Most stressing was accomplished by jacking from the outside of the building (Fig. 9). Transfer girders were stressed from within the building (Fig. 10).

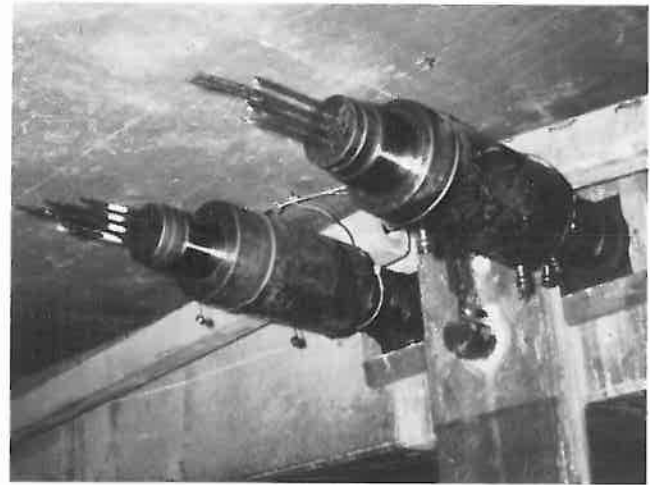
Fig. 10 — Transfer girders were stressed from within the parking garage.

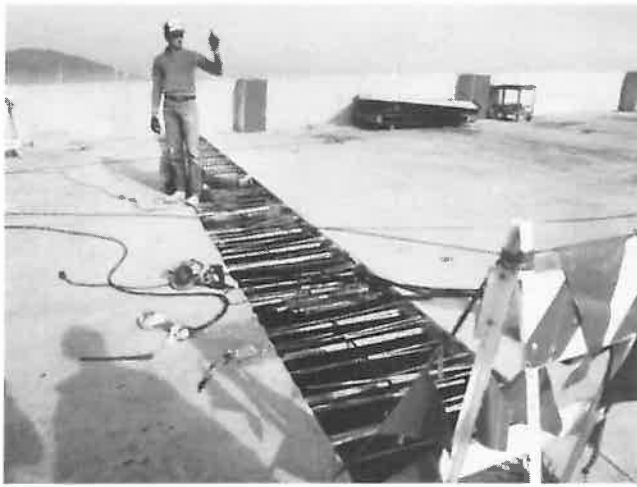
Fig. 11 — Closure strips in slabs were opened up for inspection and repair of floor slab strands.

The slab tendon replacement was done by removing the corroded ½ in. (12 mm) strands and replacing them with ¾ in., 270 k (11 mm, 1.2 MN) strand coated with epoxy. This is a relatively new product. The epoxy coating is 30 mils thick and very durable. The size of the ¾ in (11 mm) strand with the epoxy coating is approximately ½ in. (12 mm).

The slab tendons were inspected and replaced by removing 4 ft (1.3 m) closure strips located at approximately one-third points along the 370 ft (119 m) side of the structure (Fig. 11). Approximately 65 ft (21 m) of closure were removed at a time, then the tendons were inspected and the corroded ones replaced. The concrete closure was replaced prior to removal of the next 65 ft (21 m) to provide the least disruption to traffic. Approximately 10 percent of the tendons were replaced. Work on the garage started in August 1986 and was essentially complete by early April 1987. Fig. 12 is an interior view of the completed project.

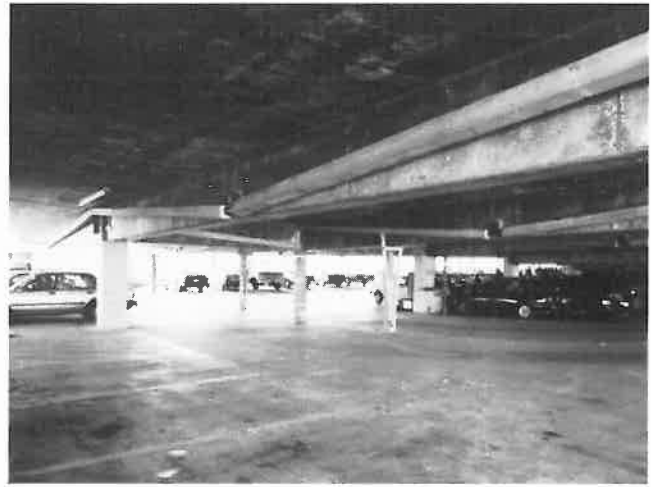
Fig. 12 — After stressing operations, the shoring was removed and the garage was returned to full operation.
