Innovative Rehabilitation of a Parking Structure

by Bijan O. Aalami and David T. Swanson

Describes the principal considerations in the evaluation, design, and construction that led to the successful rehabilitation of the multi-level Pier 39 concrete frame parking garage in San Francisco. Gradual deterioration of insufficiently protected heat-seal wrapped post tensioning had rendered the garage unfunctional and necessitated extensive shoring. Rehabilitation options, economic evaluations, structural computations, post-tensioning hardware, and construction highlights are discussed.

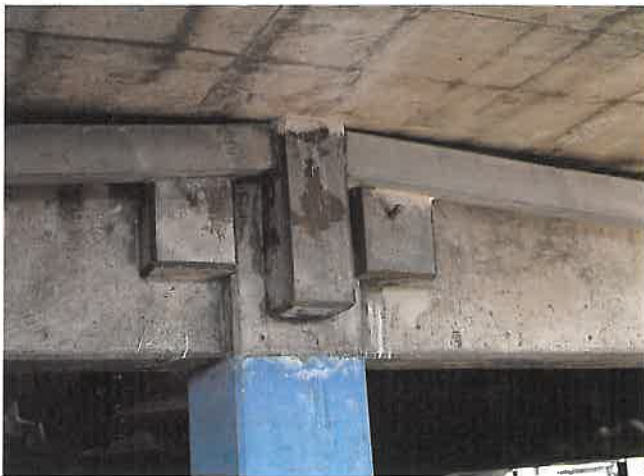
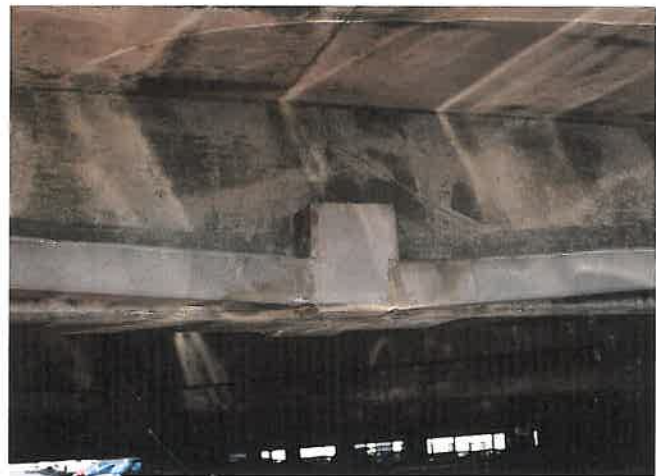
Fig. 3 — (top) Addition of steel trusses was one of the rehabilitation options.

options are shown in Fig. 3 and 4.

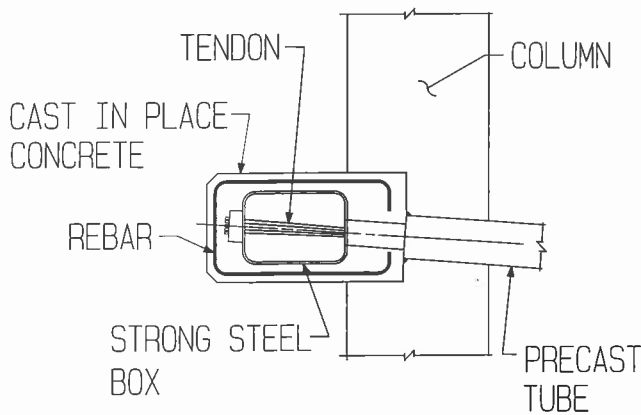
Fig. 8 — (left) The tendons react behind the columns against strong steel boxes that were subsequently encased in cast-in-place concrete for corrosion and fire protection.

The beam hardware consists of two components. First, the end brackets that wrap around the columns and transfer the applied post-tensioning load to the structure incorporate 8 x 12 x ½ in. (20.3 x 30.5 x 13 mm) tube sections with stiffeners at the tendons (Fig. 8). The design was governed by shear.
